APHS Management Recommendations for Abbott Product Defect Correction August 2023

GALLANT™, NEUTRINO™ NXT, and ENTRANT™ ICDs and CRT-Ds manufactured prior to April 2022

(Models CDVRA500Q, CDDRA500Q, CDHFA500Q, CDVRA600Q, CDDRA600Q, CDHFA600Q, CDVRA300Q, CDDRA300Q, and CDHFA300Q)

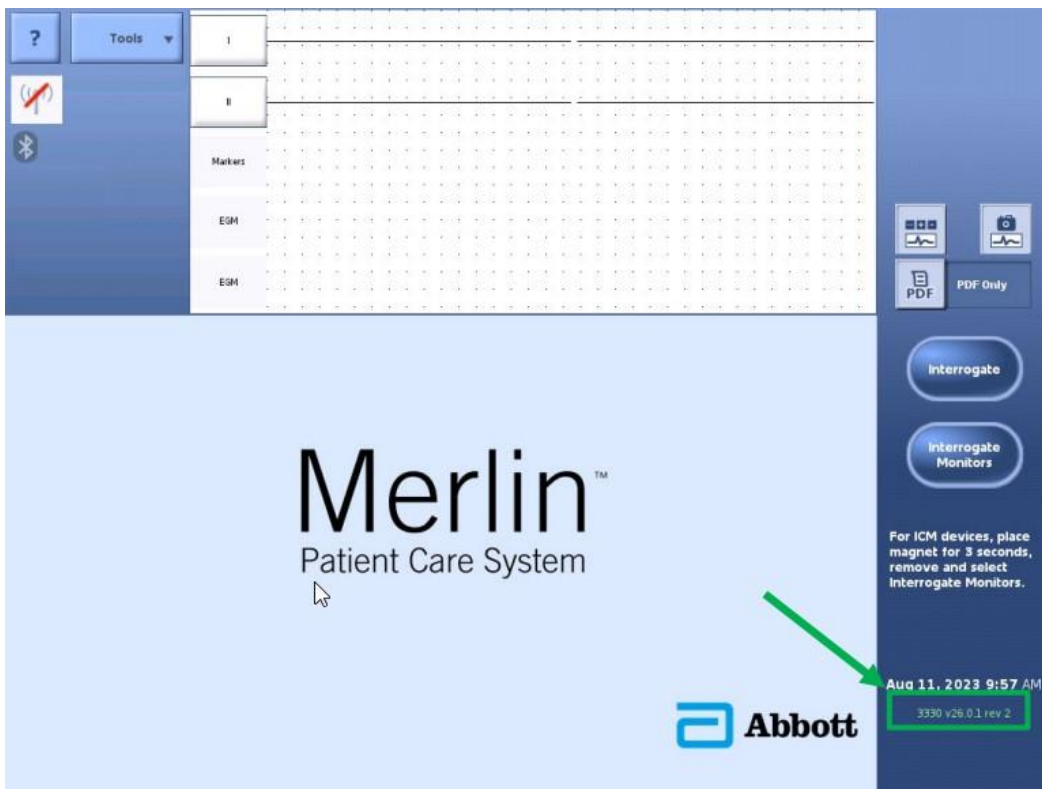
Identifying Merlin™ PCS 3650 Software Version

The Merlin™ PCS 3650 software version is visible on the lower right corner of the initial startup screen, as displayed in the image below. Confirm the programmer software version is 3330 v25.4.1 or higher.
