APHRS Product Notification Notice 22nd November 2019 Device:

Product	ARTG
Claria MRI™ CRT-Ds	280183; 280186 ; 281607; 281608
Amplia MRI™ CRT-Ds	280182; 280184 ; 281606
Compia MRI™ CRT-Ds	280181 ; 280185
Viva™ CRT-Ds	203210 ; 203211; 203212; 203840; 219221; 219222; 230204
Brava™ CRT-Ds	219220
Visia AF™ ICDs	280351; 280352; 280353
Visia AF MRI™ ICDs	280354; 280355; 282960; 282961
Evera™ ICDs	206324; 208024; 208025; 208026; 208027; 208028; 208029; 208030
Evera MRI™ ICDs	208030; 230019; 230020; 230021; 230022; 281609; 281610; 281611; 281612
Primo MRI™ ICDs	312640 ; 312641; 312642; 312643
Mirro MRI™ ICDs	Not sold in Australia

Description:

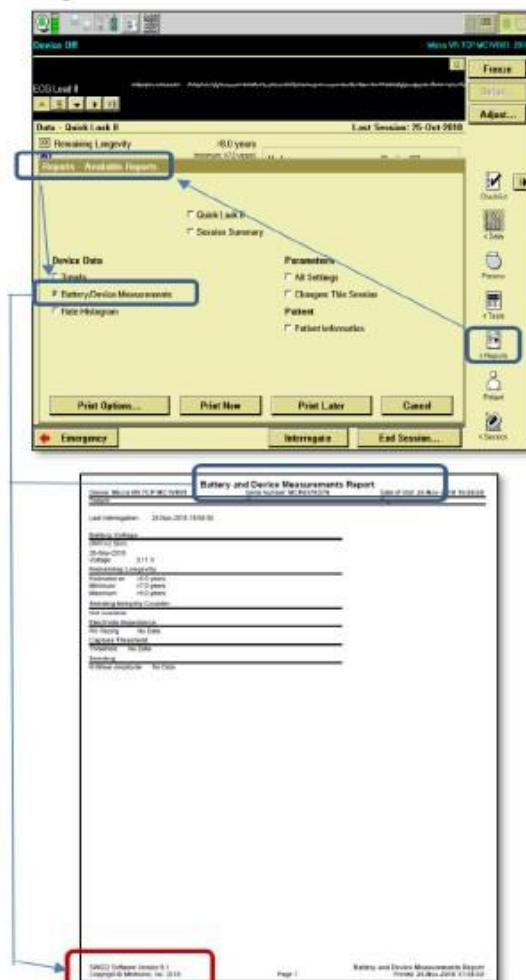
Images 2a and 2b

Any CareLink transmission completed after **17 January 2019** will report the updated remaining longevity estimate. For in-clinic patients who have been interrogated via a programmer, the clinician can view the Battery and Device Measurements Report (Images 2a and 2b) and verify that the Software Application Model ID located in the lower-left corner of the report indicates "SW022 Software Version 8.1".

- Select Reports (see image 2a)
- Select Battery/Device Measurements
- Click Print Now
- Verify the software version printed on the lower left-hand corner is "SW022 Software Version 8.1"
